Blackout in Spanish Peninsular Electrical System the 28th of April 2025

18/06/2025

System Operation Division

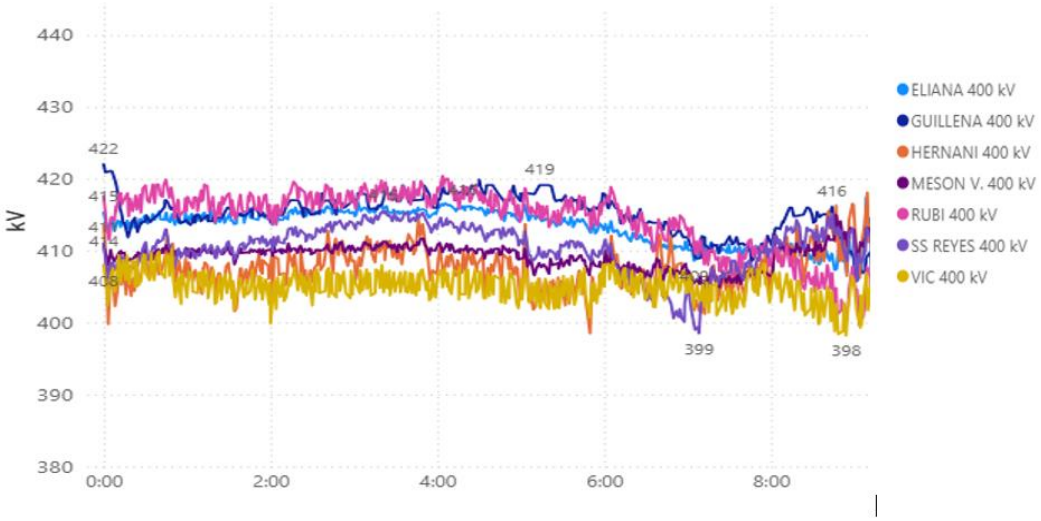
Figure 1. Voltage in 400 kV transmission network from 00:00 to 09:00 h

The voltage profile in the Transmission Network remained stable with minimal voltage variations until 6:00 h, coinciding with a change in the interconnection exchange with France. From that moment, voltages dropped at the same time as the demand rose until 9:00 h. During this period, two very low amplitude interarea oscillations appeared in the European system without any consequence, which is within the normal range for an electrical system with the size of the European one.

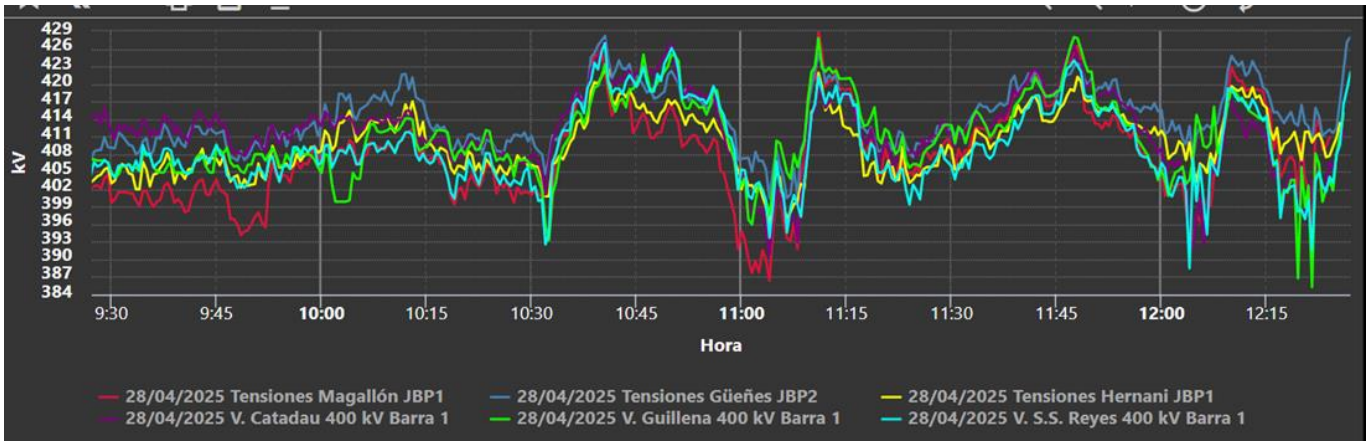
Figure 2. Voltage in 400 kV transmission network from 09:30 to 12:30 h

From 9:00 h to 12:00 h, a greater variability in voltages was observed, attributable to the change in the generation mix and demand variations, but without any major excursions. From 10:00 h onwards, coinciding with changes in the interconnection exchange and/or adjustments in balancing energies, voltage variations occurred in the transmission network substations, particularly around 11:00 h, when voltages dropped below 400 kV by about 10 kV.

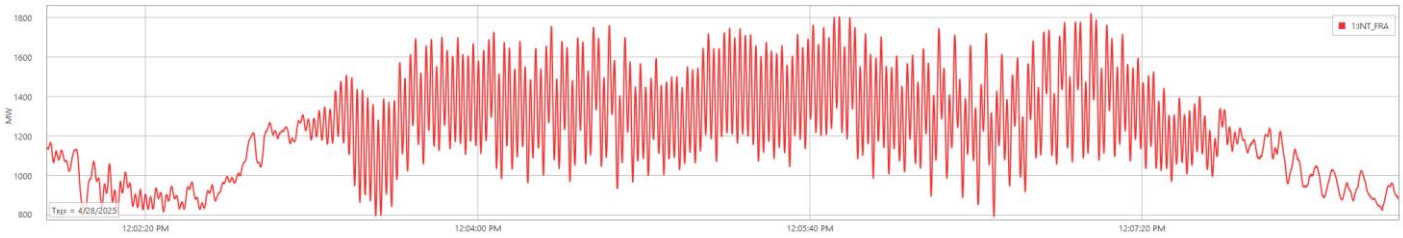
Figure 3. Exchange Spain-France between 12:02 to 12:08 (0.6 Hz oscillation)

At **12:03 h, and for a duration of 4 minutes and 42 seconds, a significant 0.6 Hz oscillation** was observed in the electrical system. Coinciding with this, the damping of the 0.2 Hz frequency range dropped from 20% to 5%. Prior to the event, system voltages were close to nominal values, but the **oscillation caused a decrease in average voltage, with fluctuations reaching up to 30 kV** in the most extreme cases, ranging between 375 kV and 410 kV depending on the substation. The oscillation could be seen also in the power exchange with France.

In response to this situation, REE Control Center **activated the pre-established measures** to improve oscillation damping and attempt to eliminate it:

- Coupling 400 kV transmission lines to reduce the system impedance.
- Reduction of export exchange with France by 800 MW until setting an export program of 1,500 MW.
- Changing the HVDC link operational mode with France to constant power mode (setpoint: 1,000 MW from Spain to France).

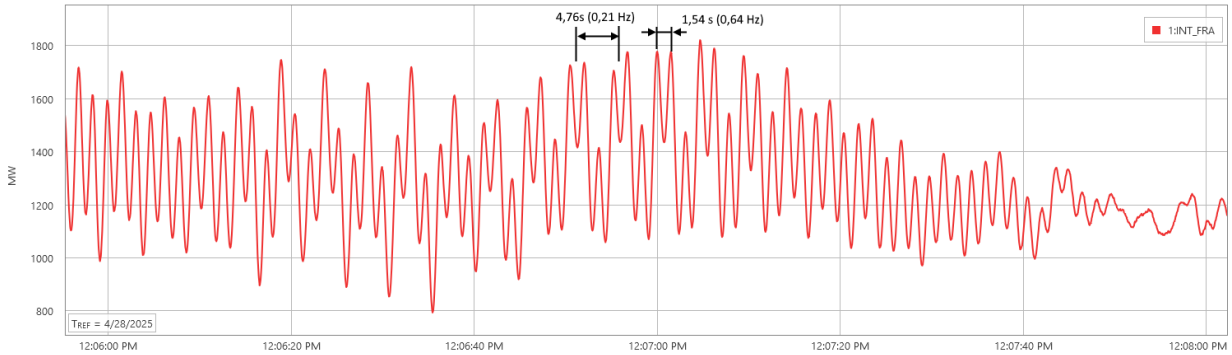
Figure 4. Exchange Spain-France between 12:06 to 12:08 (0.6 Hz oscillation)

Almost at the end of this oscillation also the 0.2 Hz mode could be clearly seen coupled with the 0.6 Hz mode in the power exchange with France.

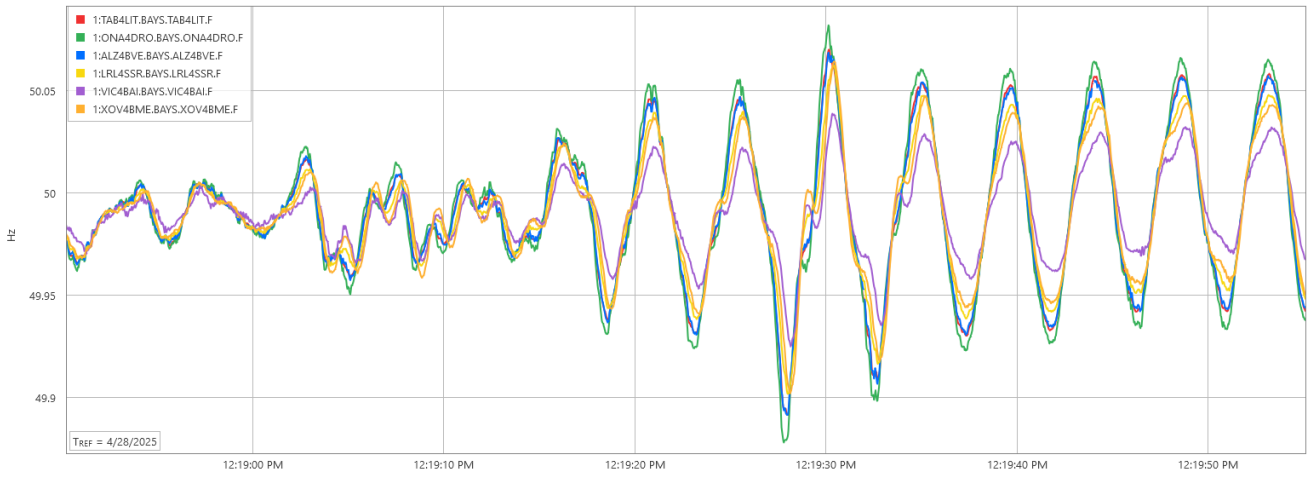
Figure 5. Initial moments of the 0.2 Hz oscillation where 0.6 Hz oscillation can also be observed

A detailed analysis revealed that the oscillation initially began at 0.6 Hz, and quickly afterwards the 0.2 Hz oscillation started. Although PV Plant A had increased its output from 250 MW to 350 MW at 12:15 h and no active power fluctuations were observed, variations in reactive power were indeed detected.

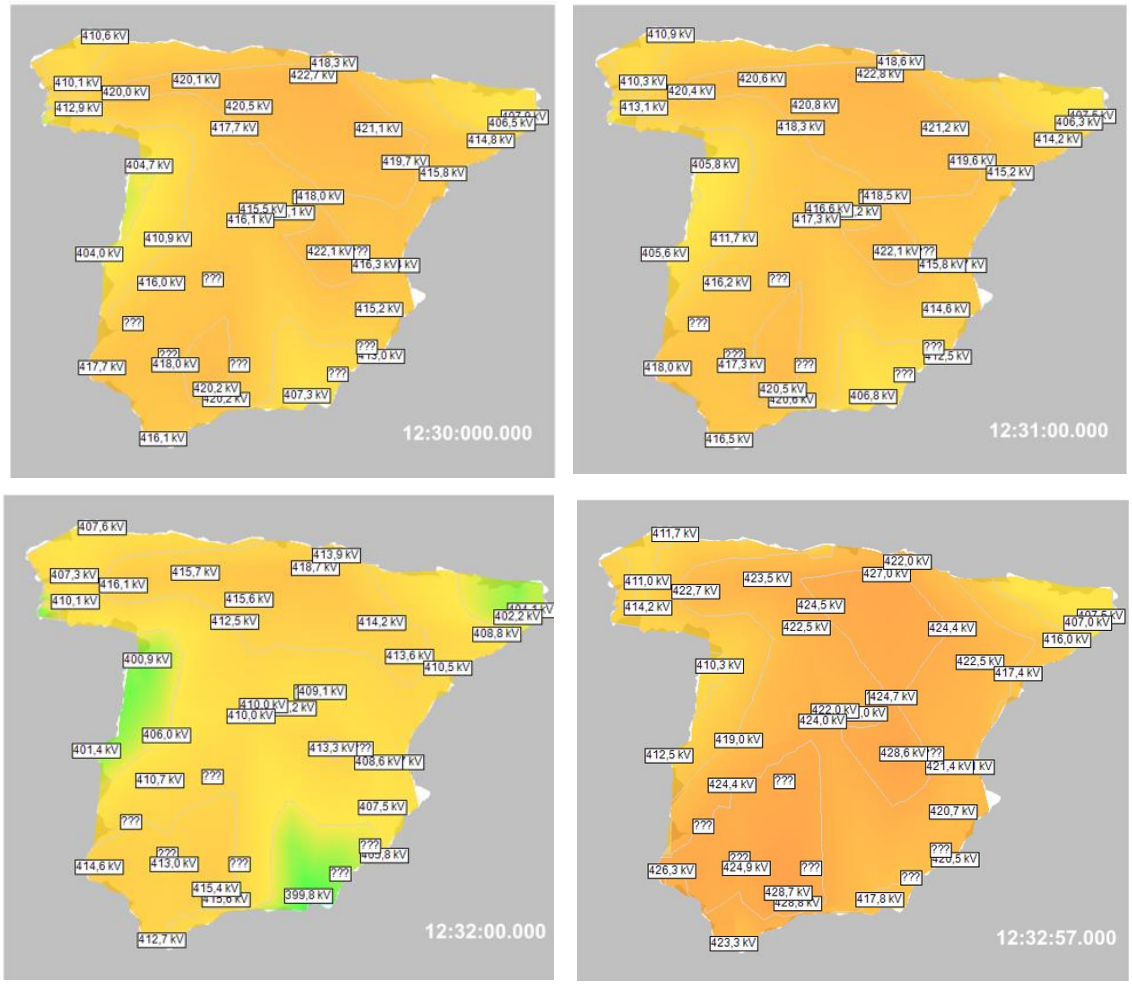
Figure 6. Phase-to-phase voltage in the Spanish 400 kV network

By 12:30 h, both voltage and frequency remained within the operational limits required by the System Operator (375–435 kV for 400 kV systems and 200–245 kV for 220 kV systems). However, a continued upward trend in voltage levels was observed.

During the program adjustment window, which spans from -5 to +5 minutes, it is common for imbalances to occur between the activation of upward or downward regulation in each country. As a result, voltage fluctuations may arise. These variations must be managed primarily by generating units subject to Operating Procedure P.O. 7.4, which provide dynamic voltage control. This is so because the available resources within the transmission network don't provide dynamic voltage control.

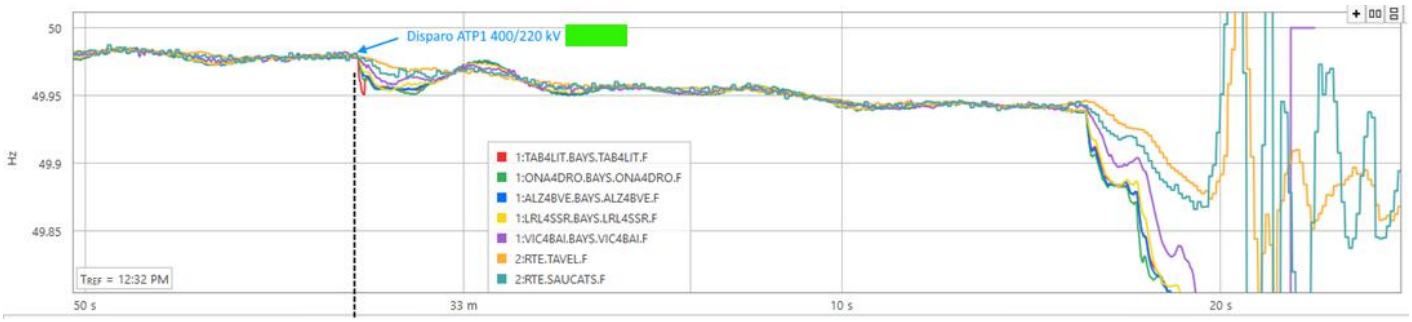
Figure 7. Evolution of the system before and after the trip in Granada

At 12:32:57 PM, a trip occurred at a substation located in the province of Granada involving the 220 kV side of 400/220 kV generation transformer, which at the time was supplying 355 MW to the transmission grid and absorbing 165 Mvar. The voltage at that transmission substation was below 418 kV, within the acceptable range. This is evidenced by the fact that, following the trip, voltages increased to 424 kV.

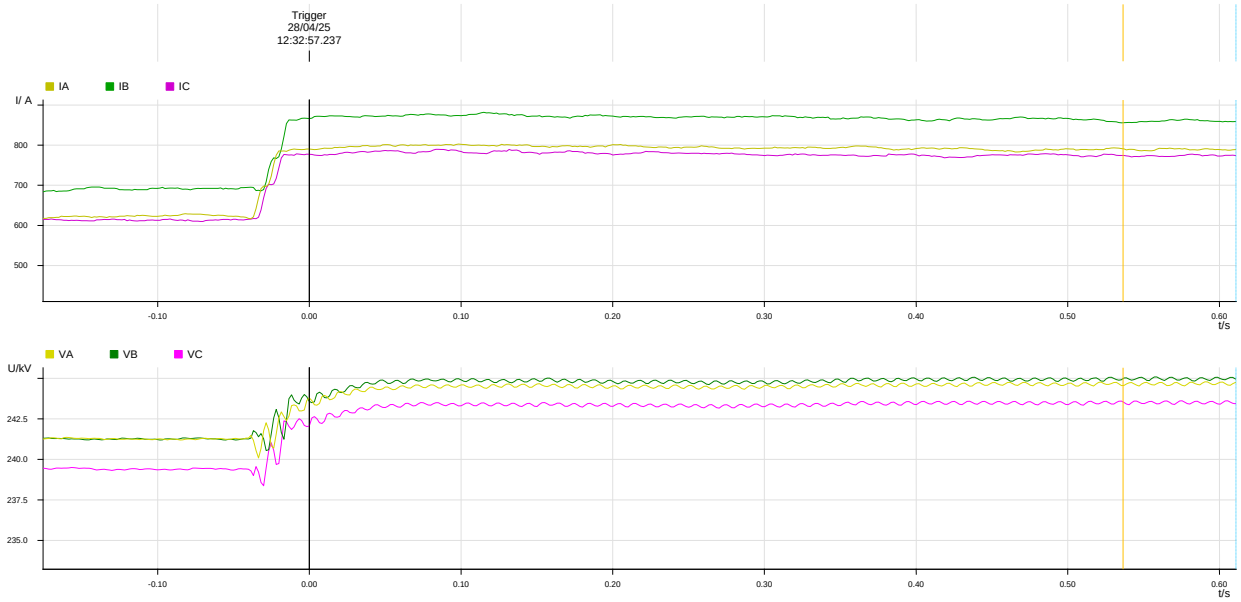
Figure 8. Line protection relay oscillography recorded simultaneously with the transformer trip[5]

The following figure shows the oscillography recorded by one of the protections of the 400 kV transmission substation where this generation is connected.

Since there were no overvoltages on the transmission network 400 kV side —and the values were well below such thresholds—. It could, once again, be inferred that the cause lies in the generator transformer tap setting. As the system was recovering from previously low voltages, the transformer was likely operating with a tap position configured to maintain appropriate voltage levels at the 220 kV collector substation and the associated evacuation network. As voltages began to rise, the tap changers may not have responded quickly enough, potentially resulting in overvoltages on the secondary side without corresponding high voltages on the primary side of the transformer.

The disconnection of this installation is not correct, as the voltage in the point of connection with the transmission system remains within the limits established in grid codes.
